LIQUID HYDROGEN POSITIVE EXPULSION  
BLADDERS

Contract NAS 3-11192

THE BOEING COMPANY

FINAL REPORT

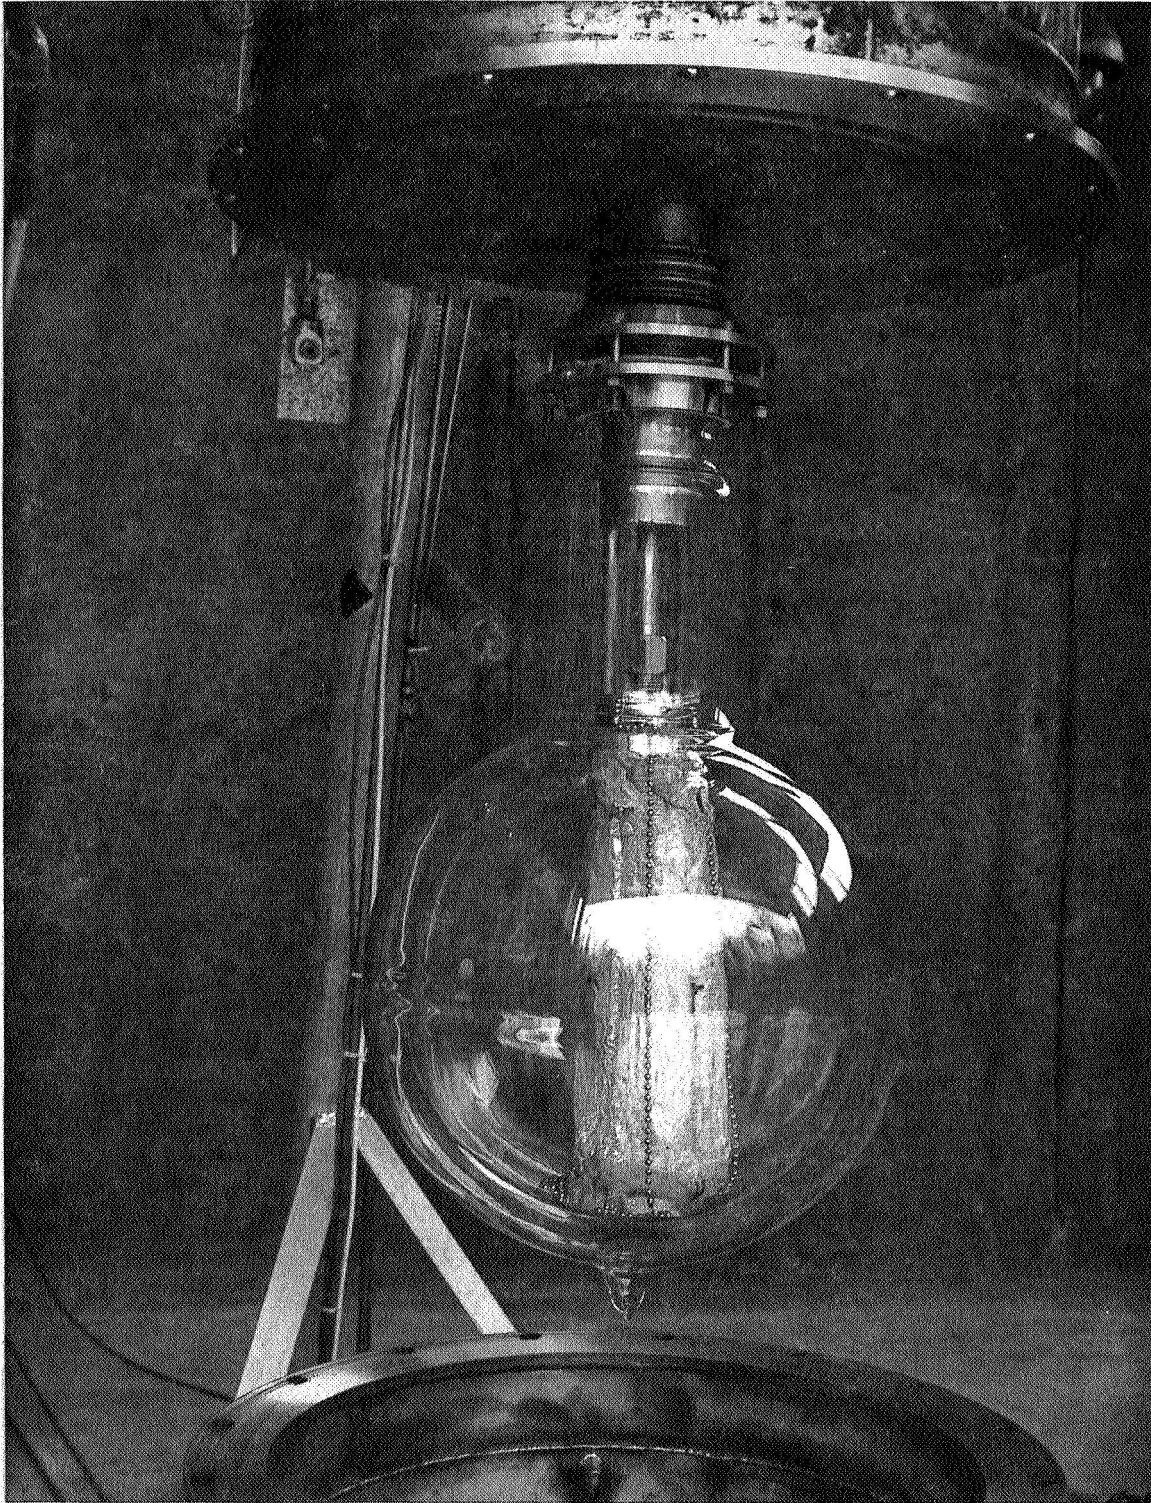
FIGURE 17 COLLAPSED BLADDER (75°F)

The collander chains successfully prevented sealing of the test bladders against the test dewar walls and the trapping of liquid hydrogen. There was no evidence of the collander chains causing tearing or degradation of the bladder. Figures 17 and 18 show the positioning of the collander chains around a bladder collapsed and expanded at ambient temperature. The reason for employing the collander chains instead of a fabric collander was to allow for motion picture coverage of the bladder tests. The motion picture records of the bladder tests proved to be one of the most valuable aids in evaluating the performance of the bladders. The degree and pattern of collapse of the bladders could be accurately judged during the fill phases of the cyclic expulsion tests, and the flow path of the liquid hydrogen could be followed during the expulsion phases. Liquid hydrogen between the plies of a bladder, when it occurred, could be readily detected.

There was no indication of a controlled collapse pattern on this bladder. This can be attributed to the fact that the control device was bonded on the inner, porous, Nomex ply and probably did not expand into position against the wall of the test dewar before it was rigidized by the cryogenic temperature. The inherent stiffness of the Nomex material would also contribute to a mislocation of the collapse control device.
